DOT/FAA/AR-02/62

Crash Simulation of Vertical Drop Tests of Two Boeing 737 Fuselage Sections

August 2002

Final Report

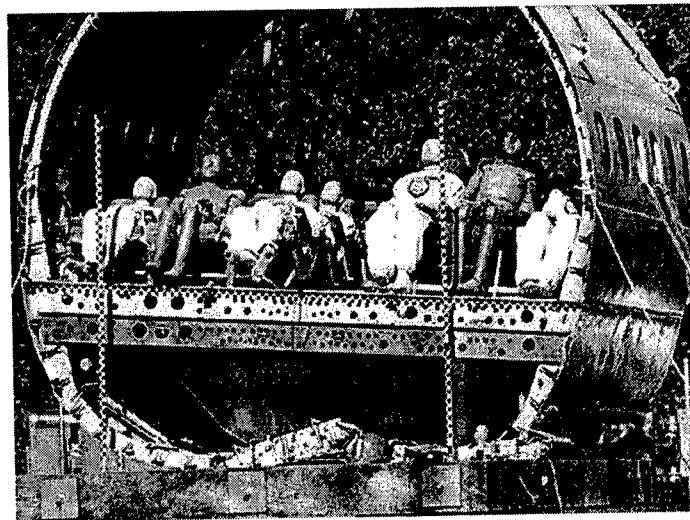
A posttest photograph of the fuselage section is shown in figure 6. Damage consisted of severe yielding and fracture of the lower fuselage frames and wrinkling of the skin on the lower left side of the fuselage section. The deformation of the lower fuselage was asymmetric about the centerline due to the presence of the cargo door and its associated stiffened structure located on the lower right-hand side of the fuselage. On the left-hand side, additional fuselage frames fractured. Similar damage was not observed on the right-hand side of the fuselage. The auxiliary fuel tank was punctured from below, causing water leakage posttest. In addition, failure of the seat tracks and major structural damage to the seats were observed, especially on the right-hand side of the fuselage floor [6].

FIGURE 6. POSTTEST PHOTOGRAPH OF B737 FUSELAGE SECTION

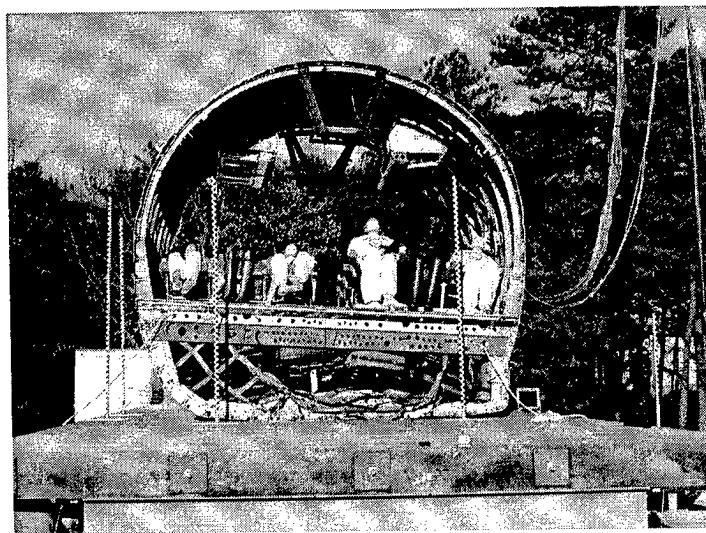
A posttest photograph of the fuselage section is shown in figure 9. The location and type of damage experienced by the second fuselage section was similar to that incurred during the 1999 test. The damage consisted of yielding and fracture of the lower fuselage frames and wrinkling of the skin on the lower left side of the fuselage section. The deformation of the lower fuselage was asymmetric about the centerline due to the presence of the door and its associated stiffened structure located on the lower right-hand side of the fuselage. On the left-hand side, a second damage site developed with fracture of the fuselage frames. Similar to the first test, all seats on the right side of the fuselage floor failed during the second test. However, no failure of the overhead bin support brackets or linkages occurred. Due to the presence of the luggage, the deformation pattern of the lower fuselage frames was more uniform than that seen in the previous test.

FIGURE 9. POSTTEST PHOTOGRAPH OF THE B737 FUSELAGE SECTION WITH OVERHEAD BINS AND LUGGAGE

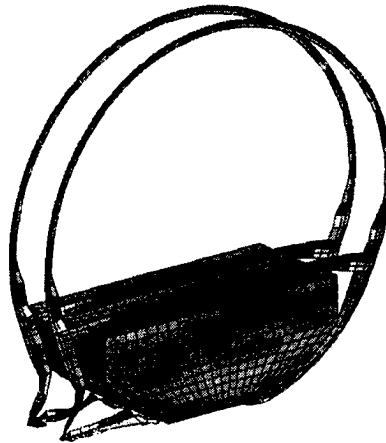
An analysis of the test data indicated that the auxiliary fuel tank came loose from the mounting track shortly after impact [6]. Consequently, the model was changed to allow the tank to move freely within the cargo hold with contact surfaces to prevent penetration of the tank through the surrounding structure. A portion of the contact force between the tank and the surrounding fuselage structure is plotted in figure 13.

FIGURE 14. TANK INTRUSION INTO THE FLOOR BEAMS AT FS 460 AND 480 AT TIME 0.07 s

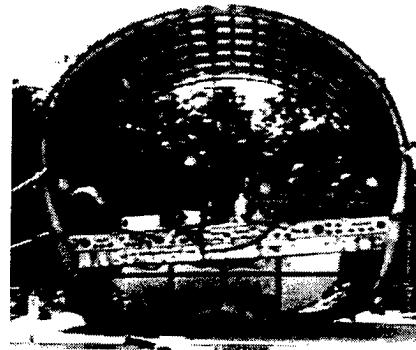
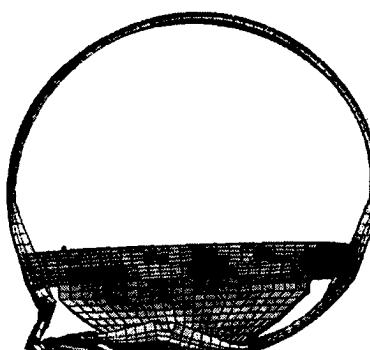
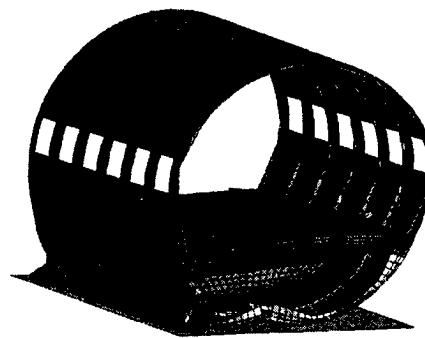
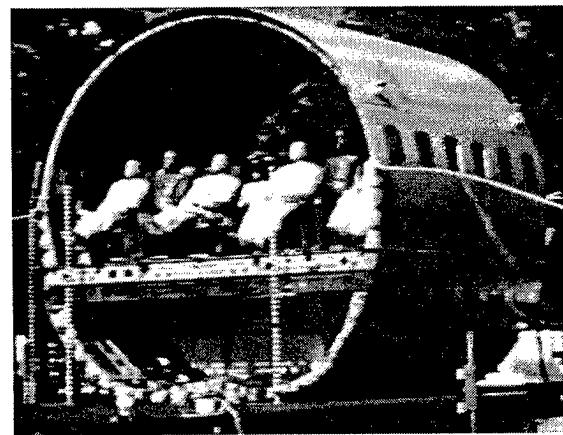
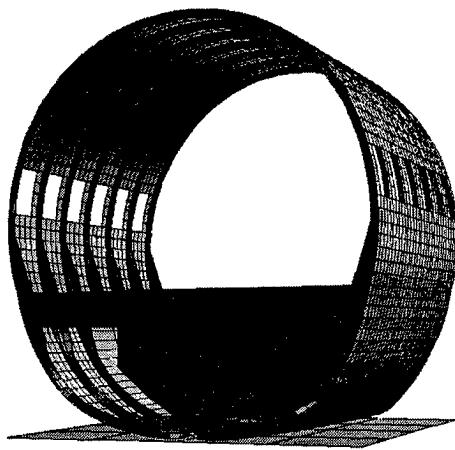
FIGURE 15. POSTTEST REAR VIEW OF TEST ARTICLE COMPARED WITH THE ANALYSIS

the floor. Front- and rear-view deformed plots of the fuselage section are compared with posttest pictures in figures 15 and 16, respectively. The plots show that the observed deformation pattern of the fuselage is closely captured by the simulation results.

(a) Posttest picture rear view

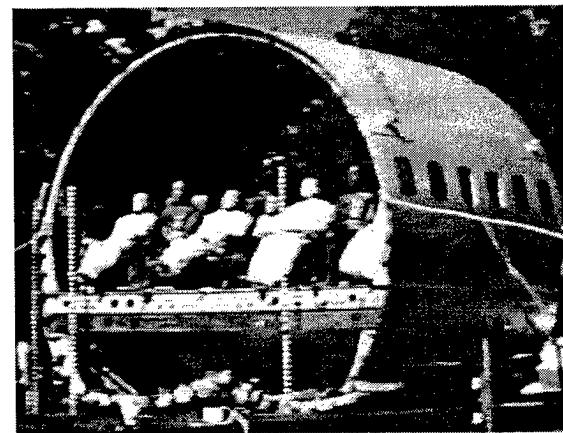
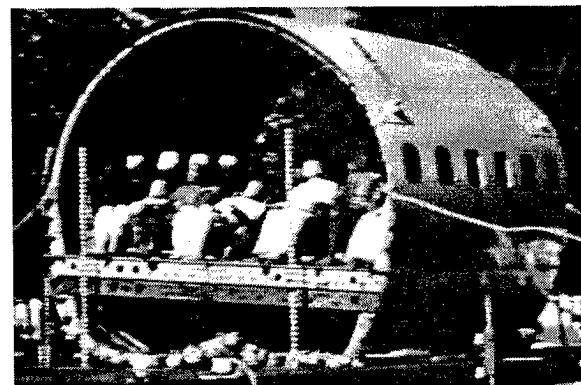
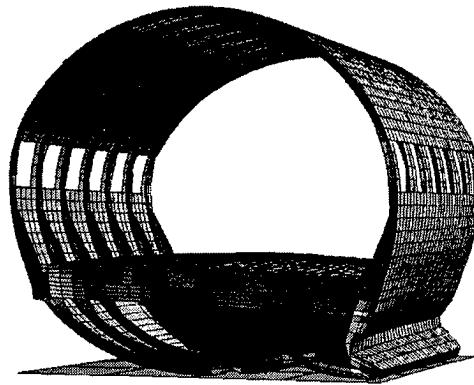
(a) Front view at time = 0.02 seconds

(b) Front view at time = 0.06 seconds

(c) Front view at time = 0.10 seconds

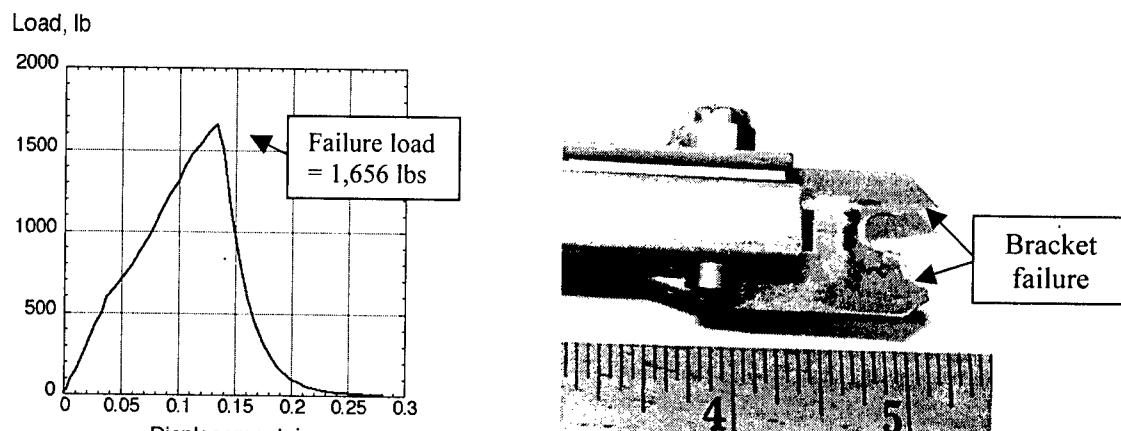
A tensile test was performed on the Heath Tecna vertical strut and bracket assembly. The notched end of the strut was loaded through the bracket and the threaded end was loaded through the eyebolt. To ensure that only tensile loads were applied, a test fixture was fabricated to align the bracket with the eyebolt. The strut was loaded quasi-statically using a bench-top load test machine. The measured load-deflection curve is shown in figure 26(a). The assembly failed at the hole where the bolt connects the notched end of the strut to the bracket, as shown in figure 26(b). The measured ultimate failure load was 1,656 lbs. This test result provides a single data point that can be used as a guideline for evaluating failure of the strut and mating bracket. However, it must be noted that the actual components may experience a much more complex loading scenario, including shear and bending during the impact test. In the model, the vertical support struts were assigned material properties typical of 7075-T6 aluminum with no yielding or failure. The axial force responses of the beam elements representing the struts were output for correlation with the calibrated load data obtained from the strain gages.

(b) Photograph showing failed bracket

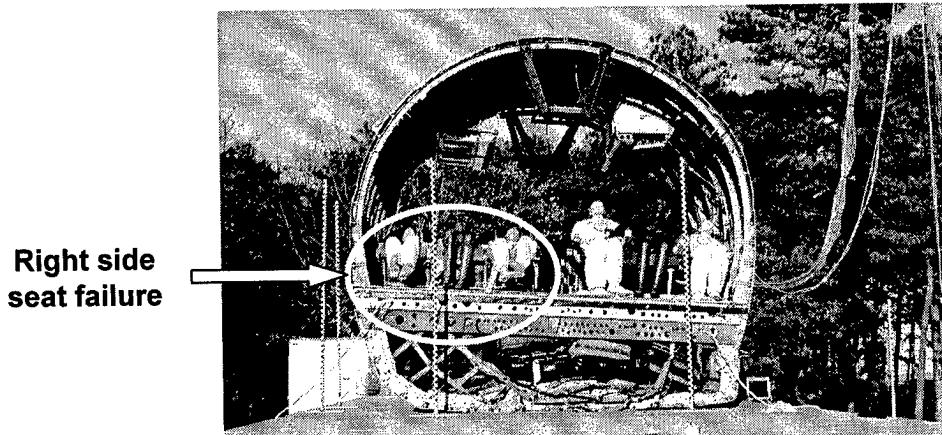
Another issue that might affect the floor-level acceleration response is the fact that all of the triple-occupant aircraft seats located on the right side of the fuselage failed during the test, as shown in figure 52. This factor is important since a large portion of the occupant weight is transmitted to the fuselage structure through the seats. In the model, the weight and inertial

FIGURE 52. POSTTEST PHOTOGRAPH OF THE B737 FUSELAGE SECTION WITH OVERHEAD BINS
